Puchberger Straße / Maria Theresien Ring Junction: Technical report

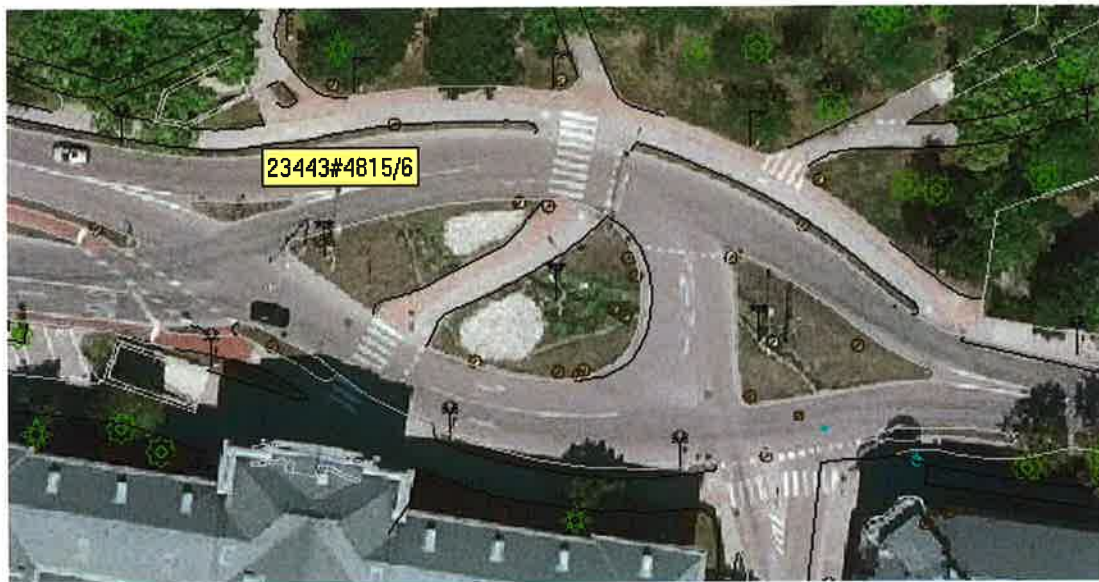
The junction takes form of an oval of approximately 70m by 30m. It has a U-turn facility for westbound traffic into Maria Theresien Ring west. The U-turn facility has a flare or queuing area that can accommodate approximately 6pcus. It is understood that the junction took this arrangement due to the paralleling Puchberger Straße and Maria Theresien East. The priorities given to the traffic streams between Puchberger Straße and Maria Theresien Ring west in both directions is possibly due to the high flow of the traffic streams.

Figure 2: Aerial photo and photographs illustrated the junction

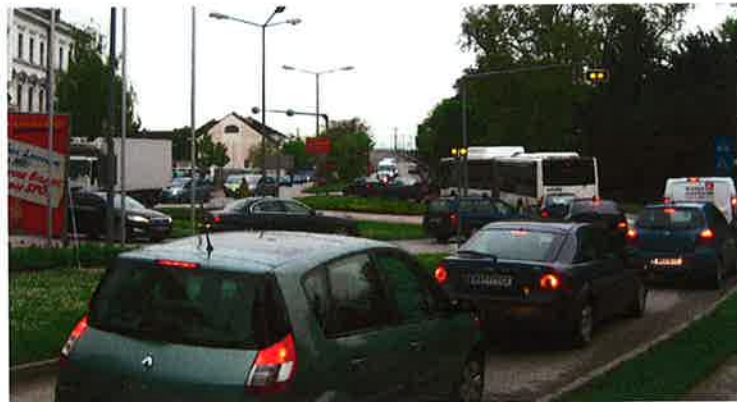
It was observed during the site visits that the junction operates below its capacity during the morning and evening peaks. However, a blocking back of traffic queue on the give-way line into Maria Theresien Ring West was observed during the morning peak. This incident although difficult to quantify from the observation, it often caused the complete locking up of the junction.

It is also observed that due to the high frequency of the local bus passing through this junction during the day (10 bus routes, approximately 18 buses per hour), the waiting area facility is often filled with 2 buses arriving at junction within a close period.

Figure 3: Junction locking up observed during AM peak period

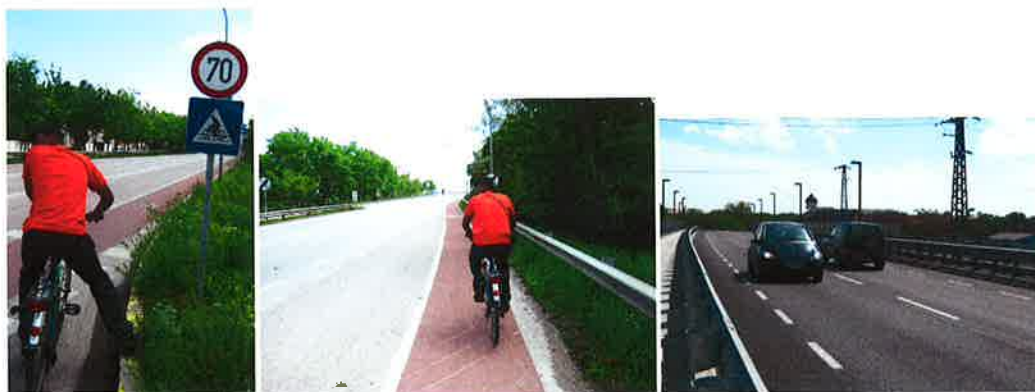
- ▶ There is no capacity problem at the junction i.e. traffic passing through the junction with minimal formation of queue length on approaches during peak periods.
- ▶ The junction locking occurred during AM peak period and is due to the inefficient waiting space for traffic turning into Maria Theresien -Ring West causing the blocking back into Maria Theresien East and subsequently the circulating lane within the junction.
- ▶ Cycle paths on Puchberger Straße Rail Bridge are Hazardous as they are placed next to the safety rail, providing no escape route for cycling out of carriageway in emergency.
- ▶ Speed limit on Puchberger Straße is 70kph. It is recommended that along the road with such speed limit cycle lane should be segregated from road traffic.

Figure 4: Other observations made during the site visit

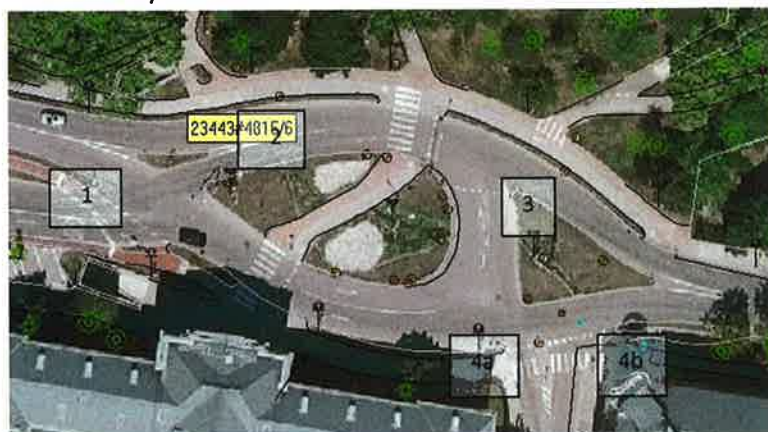
Stop line	Degree of saturation	
	AM	PM
1	0.3	0.65
2	0.71	0.64
3	0.24	0.16
4a	0.49	0.46
4b	0.05	0.05

Figure 7: Existing capacity of Puchberger Straße / Maria Theresien Ring junction

The figures above shows that the junction currently operates within its capacity during both morning and evening peak periods which is in accordance with the observation made during the site visits. The results show a higher degree of saturation on stop line 2 during both peak periods. This indicates that there may be traffic queue forming at this stop line during these peak periods.

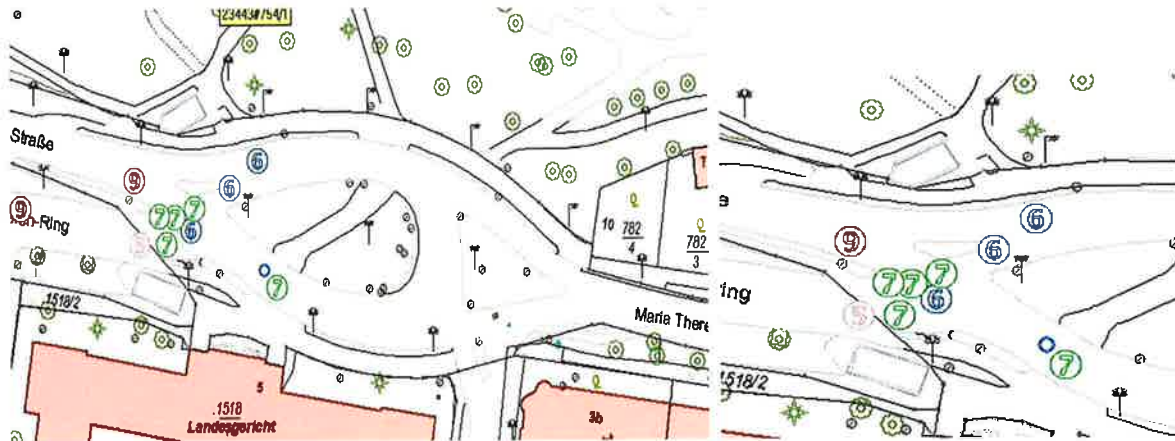
Figure 8: Screenshot taken from the GIS based accidental report program

From the GIS based accidental report, it can be seen that most of the accidents occurred at Maria Theresien ring junction occurred on the west side of the junction where the paralleling roads intersect. The analysis of the accidents record shows that there were 11 accidents occurred over 5 years, 30% of the accident is due to not respecting priority and 40% due to rear end collision (speed).

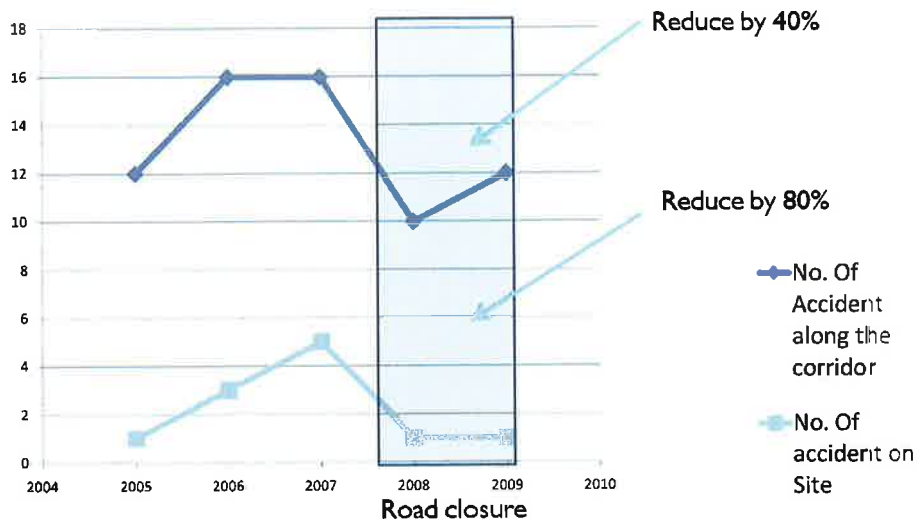
Further analysis of the accidents on the site and along the whole of the corridor shows that during the road resurfacing in 2009 which the eastbound traffic lane was closed and the speed reduction

was imposed along the corridor, the number of traffic during 2008 and 2009 reduced significantly as illustrated on Figure 10 below.

Figure 10: No. Of Accidents on site and along the Puchberger Straße - Maria Theresien-Ring corridor

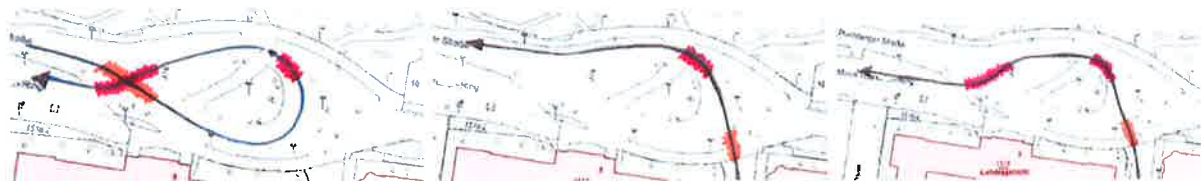
The design should also seek to reduce the number of conflict points between traffic streams, as currently traffic streams between Puchberger Straße-Maria Theresien-Ring east, Dietrichgasse-Puchberger Straße and Dietrichgasse-Maria Theresien-Ring east must pass through 3, 2 and 3 conflict points consecutively as illustrated by Figure 12 below.

Figure 12: Multiple conflict points
